Publishing date	07/11/2019
Document number	SUPAIR_2019_10_002_EN
Page number	1/1

SAFETY WARNING

SUBJECT : ACRO 4 Harness : Stitching Flaw

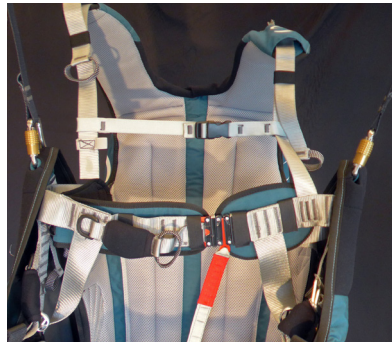
The 3 automatic vertical stitching are missing

DO NOT FLY!
Please contact
sav@supair.com
Do not use the harness until properly checked
